Residential New Build Construction Skip Dive Waste Audit Summary (Huapai Site)

Authored by: Mark Roberts and Steve Rickerby

Auckland Council Waste Planning Team

January 2024:

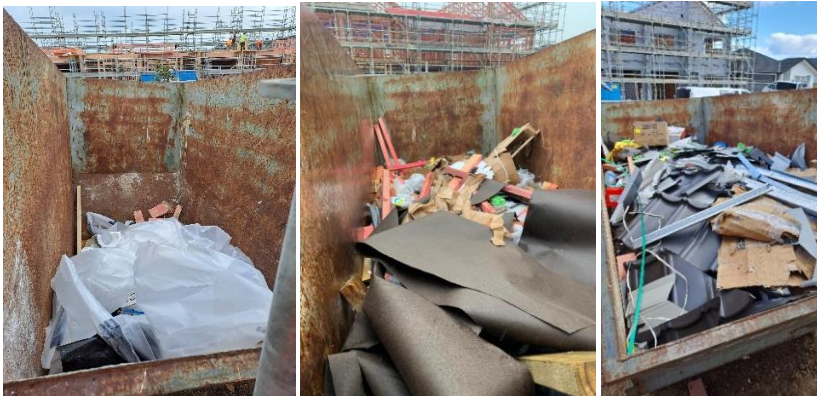
FIGURE 3: EXAMPLES OF SKIPS FILLING UP ON SITE.

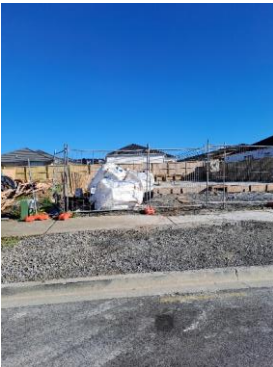
Due to timing constraints, this project was already at the foundation stage when we began the audit. This meant that we did not monitor the slab being poured however we were able to observe the floors being poured at neighbouring sites and interviewed the contractors about their processes. Very little waste is produced at foundation stage with the formwork being reused and moved from house to house in the development. Reinforcing rod and ties left on site and were captured in the audit.

FIGURE 9 EPS WASTE FROM THE FLOOR INSTALLATION AWAITING COLLECTION FOR RECYCLING

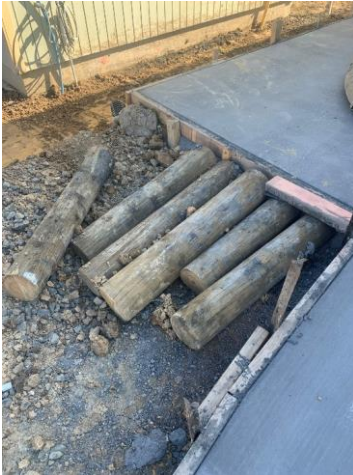
Most metal from the foundations appeared to have been recovered by the floor contractor. Some retaining wall poles were topped and these are likely to be the most significant waste from the site preparation.

FIGURE 10 TOPPED RETAINING POLES.

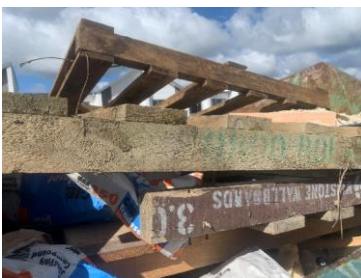
The plasterboard was not separated and it was noted that some GIB pallets (with deposits paid) were placed in the skip.

FIGURE 11 DEPOSITED GIB PALLET PLACED IN A SKIP.

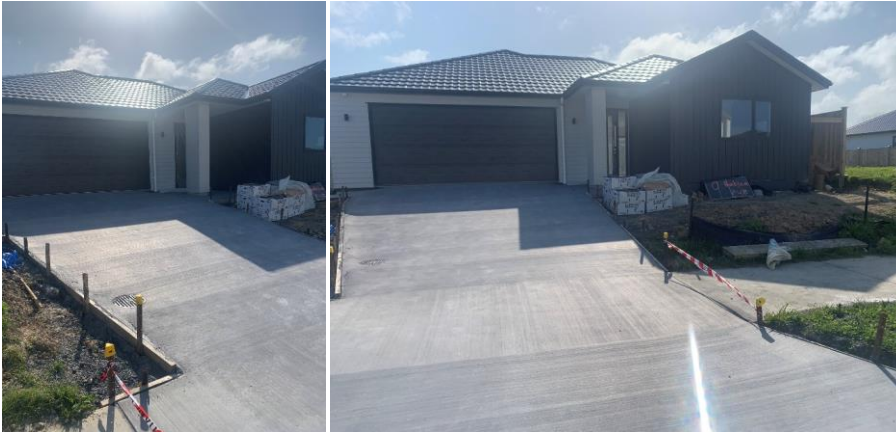
Whilst the landscaping was not included in the study, it was observed that a cut out was made in the footpath to enable a single concrete pour from the gutter to the entrance of the garage. This design typically contributes around one tonne to total waste.

FIGURE 12 CONCRETE DRIVEWAY WITHIN THE FOOTPATH CUT OUT.

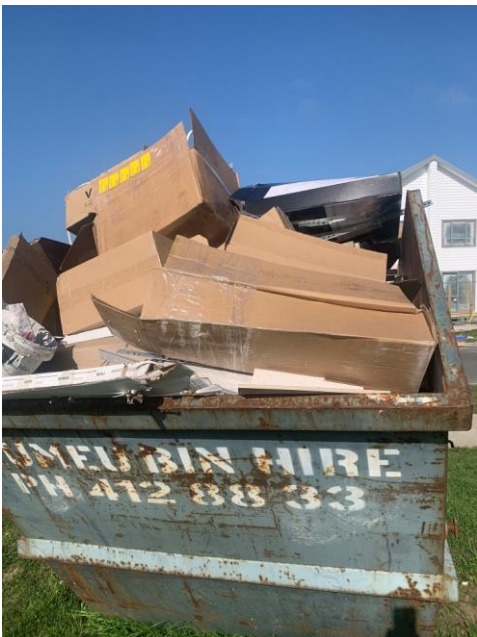
Finishing work typically attracts a lot of cardboard waste from packaging and this totalled over 800kg. Whilst volume wasn't specifically tracked, cardboard also tends to contribute waste volume as the photos below indicate.

FIGURE 13 CARDBOARD WASTE

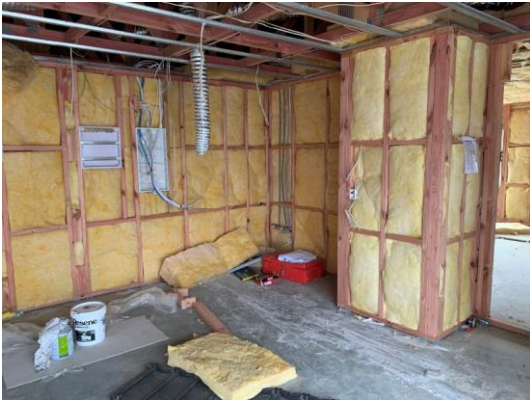
It was noted that some rework of the electrical wiring was undertaken after the insulation was installed. An unknown amount of waste would have been produced from this work, including an amount of insulation.

FIGURE 14 INSULATING MATERIAL DURING INSTALLATION.
