**Residential New Build Construction Waste Audit Summary
(Whenuapai Site)**

Auckland Council Waste Planning Team

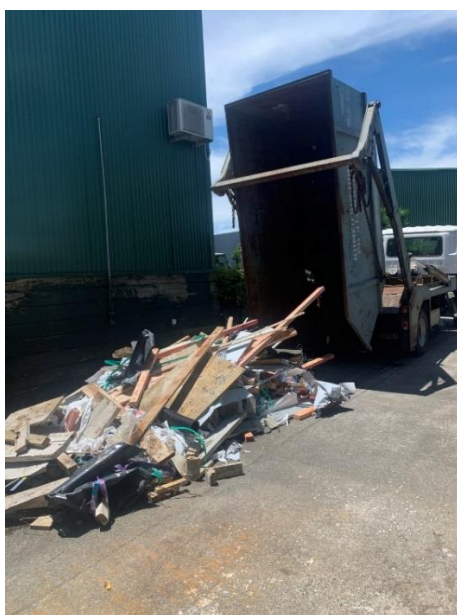
When nearing full (as per monitoring by Council staff), the bin was swapped out by our collection contractor with the full bin being tracked from site to the weighbridge at the Council owned Waitakere Transfer Station. The bin was weighed over the weighbridge and recorded on a special account created for the audit (using preloaded tare weight for truck and empty bin). The waste was then tipped out of the skip on to a clear pad/ bunker ready for sorting. A tarpaulin was used to cover the pile to ensure loose material was contained.

FIGURE 4: FIRST SKIP BEING TIPPED AT WAITAKERE TRANSFER STATION.

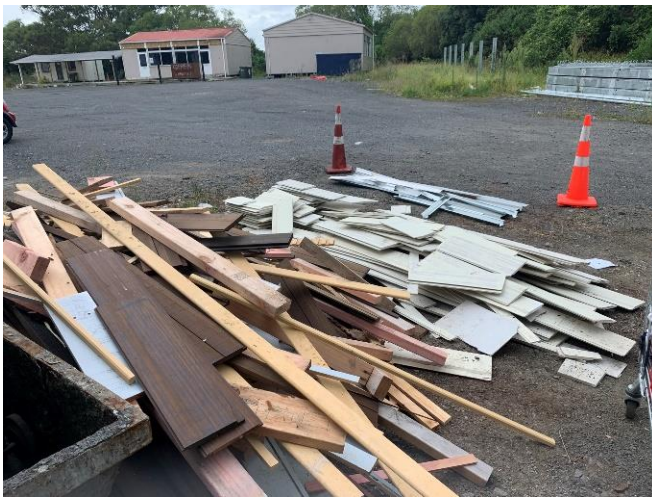
1. Pre sort to pull out and contain any loose material in wheelie bins (to avoid wind-blown litter).
2. Bulk sorting of the largest waste streams in to piles (i.e. timber, fibre cement board etc).
3. Detailed sorting and weighing of the individual waste streams. Timber waste was categorised by the dimension (such as 90 x 45) and then measured by total length and weight.

FIGURE 5: PRE-SORT IN TO WASTE TYPES.

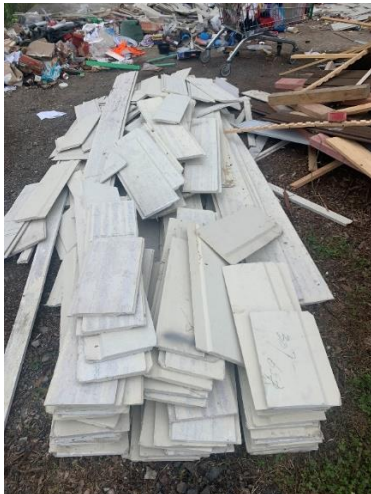
FIGURE 6: SORTED LENGTHS OF FIBRE CEMENT BOARD.

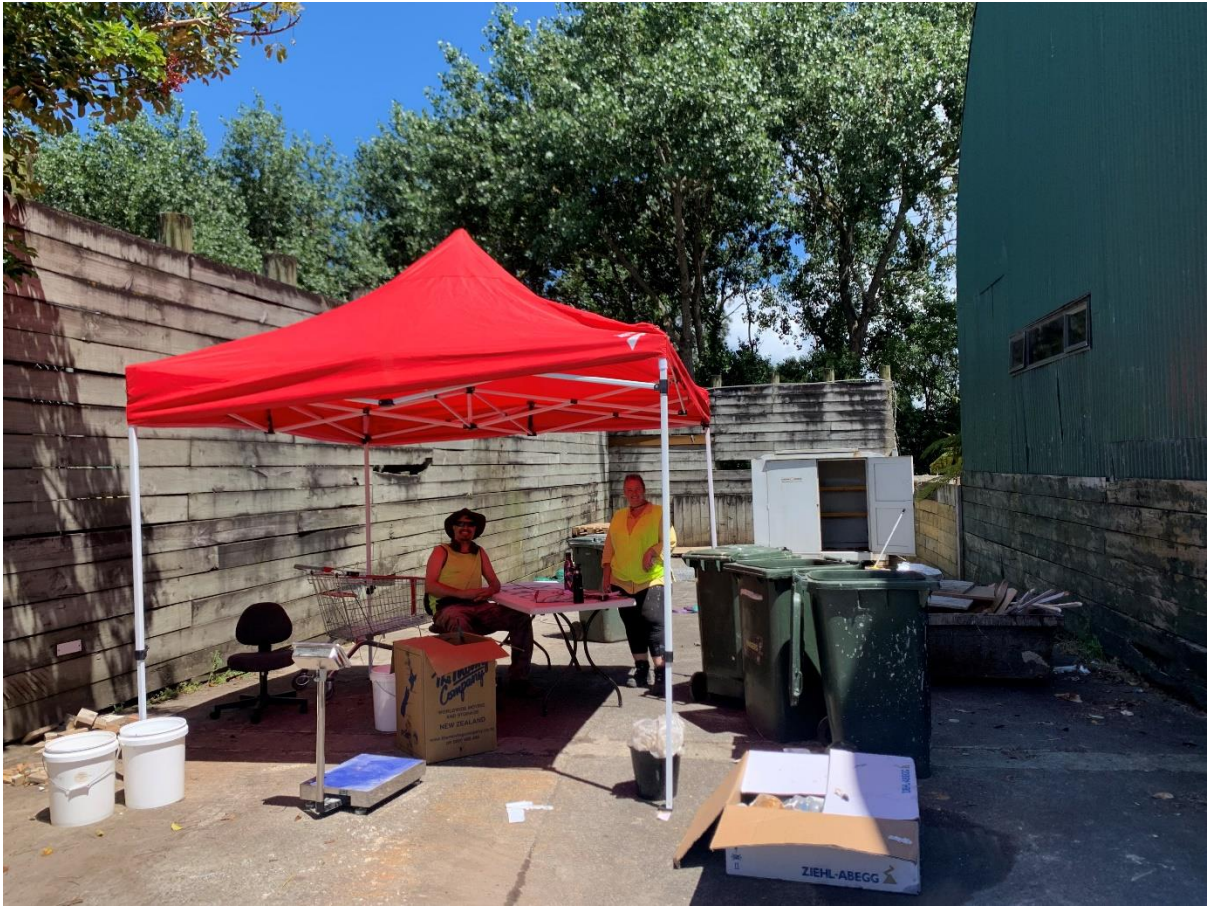
Waste sorting and weighing was completed by another contractor working in pairs. The sorting was completed in 3 stages:

FIGURE 7: WASTE SORTING BINS AND PLATFORM SCALES SETUP.

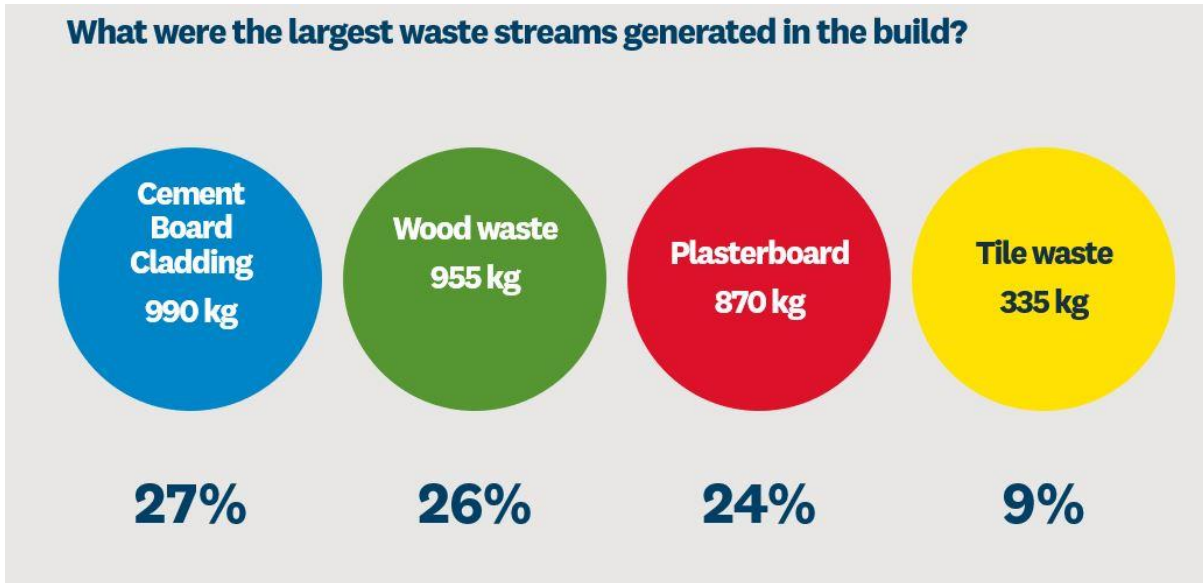
FIGURE 10: THE FOUR LARGEST WASTE STREAMS FROM THE BUILD BY WEIGHT.
